# Auto Valve Calibration Fault Recovery

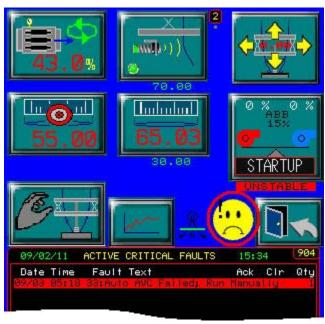
to operate on a schedule to selfcalibrate. The self-calibrate process can record faults during the process that are reported to the operator in a simple Go / No Go format. If the process ran properly, a yellow smile face is displayed. If there was an issue, the frown face (shown right) is displayed. By touching the frown face, the fault display shows and the error 33:Auto AVC Failed; Run Manually error occurs.

This document describes the steps maintenance personnel should follow to recover from this error. AVC functional description is covered for those not familiar with the system.

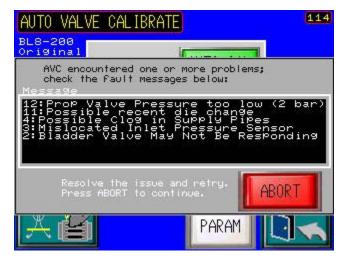
The system reports several possible error codes that helps point the maintenance personnel in the right direction. In this case, the pressure to the proportional valve was at zero. Putting it back to 2 bar corrected the issue but the other items listed could also cause a problem which is why multiple issues are sometimes listed.
