Auto Valve Calibration Fault Recovery

This document describes the steps maintenance personnel should follow to recover from this error. AVC functional description is covered for those not familiar with the system.

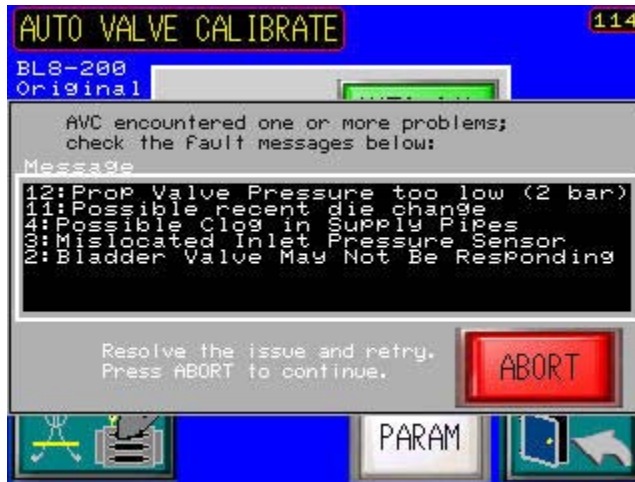
The system reports several possible error codes that helps point the maintenance personnel in the right direction. In this case, the pressure to the proportional valve was at zero. Putting it back to 2 bar corrected the issue but the other items listed could also cause a problem which is why multiple issues are sometimes listed.
