Auto Valve Calibration Fault Recovery

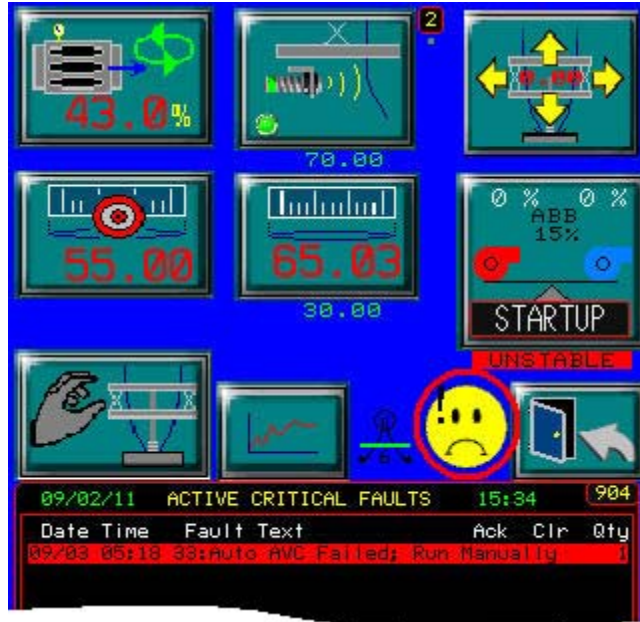
The automatic valve calibration (AVC) process provides an automated method of calibrating the flow control valve used in the IBC system. The process can be configured to operate on a schedule to self-calibrate. The self-calibrate process can record faults during the process that are reported to the operator in a simple Go / No Go format. If the process ran properly, a yellow smile face is displayed. If there was an issue, the frown face (shown right) is displayed. By touching the frown face, the fault display shows and the error 33:Auto AVC Failed; Run Manually error occurs.

This document describes the steps maintenance personnel should follow to recover from this error. AVC functional description is covered for those not familiar with the system.

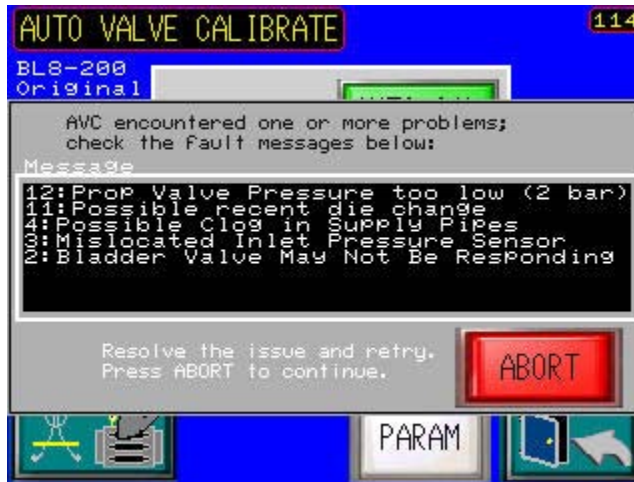
The system reports several possible error codes that helps point the maintenance personnel in the right direction. In this case, the pressure to the proportional valve was at zero. Putting it back to 2 bar corrected the issue but the other items listed could also cause a problem which is why multiple issues are sometimes listed.
