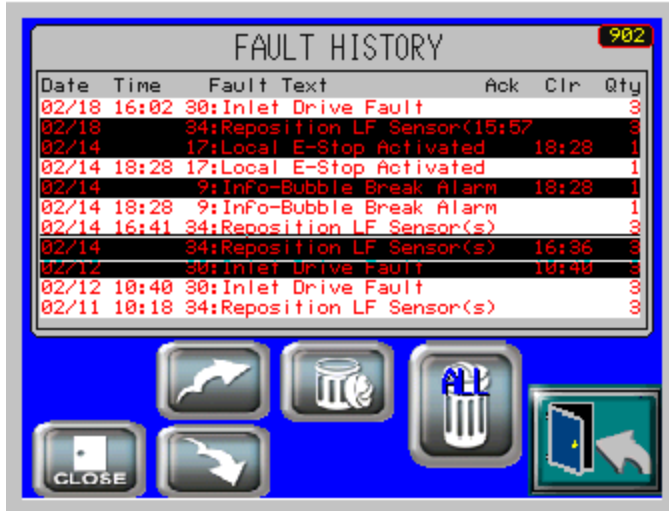
Press

to open Historical Fault data handling buttons including:

Scroll

Delete

NOTE: Former Critical Faults CAN be cleared from the Fault History list
